EXECUTIVE SUMMARY

This memorandum summarizes the findings of Bridging Solutions inspection and evaluation of the Harbour Drive Bridge over Mooring Bay (FDOT #035250), Naples, Florida. It also provides recommendations for maintenance repairs. The bridge is 54 years old and the most recent FDOT Bridge Inspection Report (01/16/19) overall condition ratings are summarized below. A site map is attached.

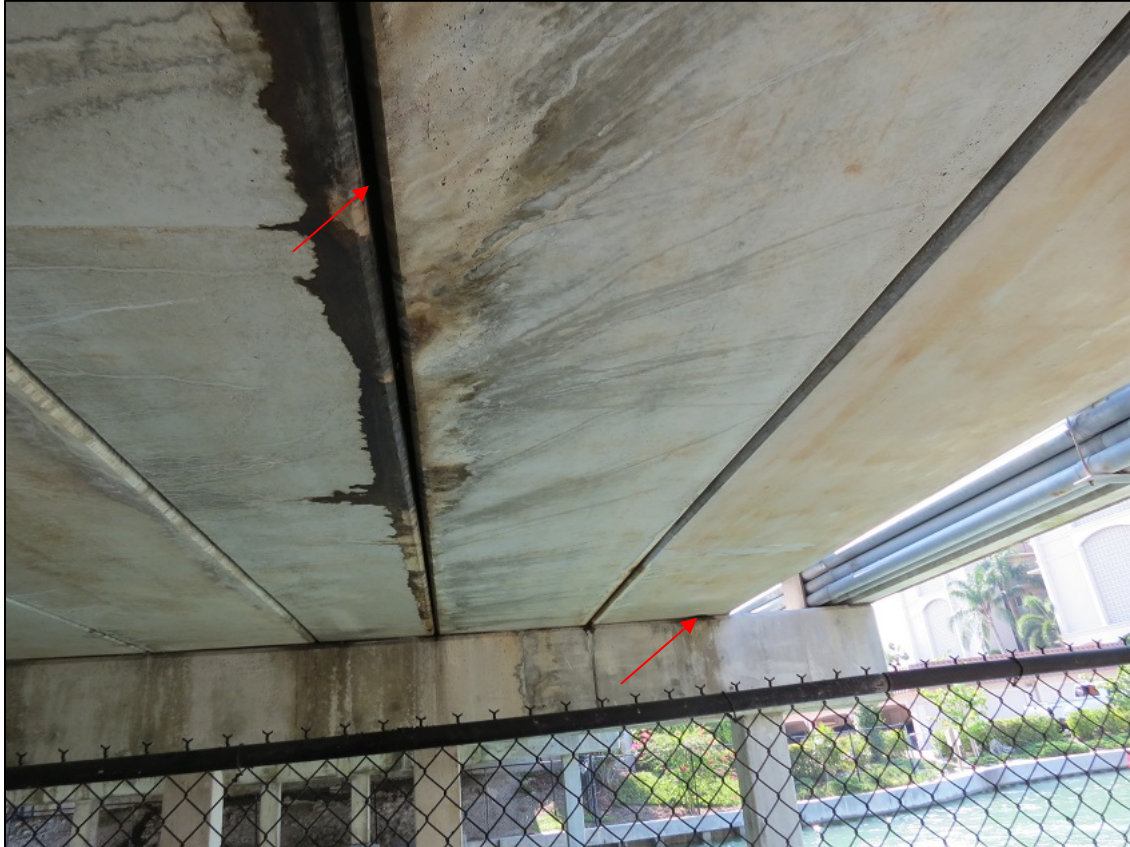
1. Slab Unit 1-12 has a spall 6in. x 6in. x 1in. at Bent 2.
2. There is evidence of water leakage between some of the joints between the slab beams.
3. There is evidence of bats living in between some of the slab beam joints.

Minor spall at Slab Unit 1-12 and leakage through joints

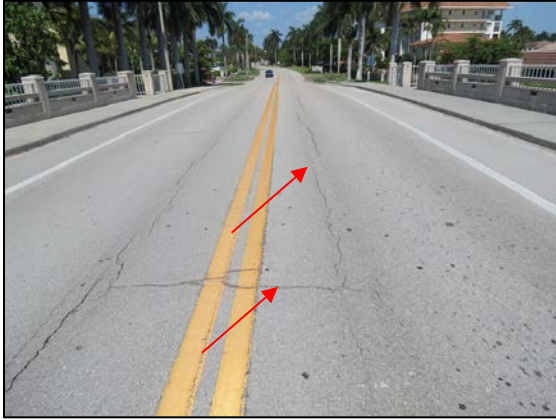
The 2 inch thick asphalt wearing surface has longitudinal and transverse cracks between 1/2" and 3/4" wide. The longitudinal cracks appear to be reflective cracks at joints between slab beam units. The cracks allow water to flow down between the joints in the slab beams. See photos below. The 2019 FDOT Bridge Inspection Report lists the wearing surface as a Condition State of 3 (poor).

Typical condition of wearing surface

1. Removal and replacement of the asphalt wearing surface on the bridge deck and approach slabs.
2. Installation of a waterproofing membrane on top of the bridge deck and approach slabs.

3. The new asphalt will be saw cut over the expansion joints to control cracking and the saw cut will be filled with liquid asphalt.
4. The asphalt overlay would extend off the ends of the approach slabs at least 22 feet and would terminate at a saw cut in the asphalt.

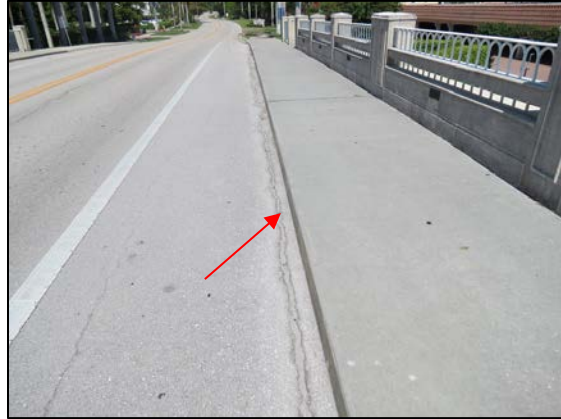
Typical cracks along curb lines (at widening joint)

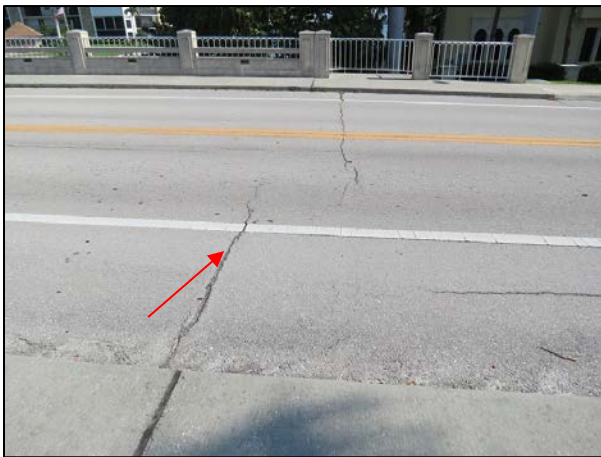
The FDOT Bridge Inspection Report lists the expansion joints as a Condition State of 1 (good). The pourable sealant in the expansion joints over the bents is covered with an asphalt overlay. There is partial adhesion failure and deterioration of the poured expansion joints in the sidewalks at Bent 3.

Covered expansion joint at Bent 4

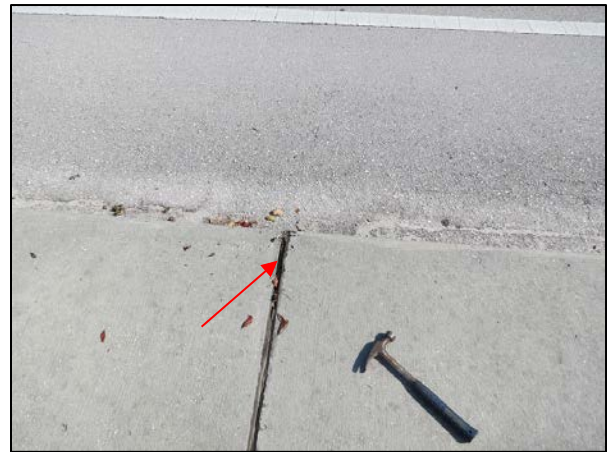
Adhesion failure (12" long) in sidewalk joint at Bent 3

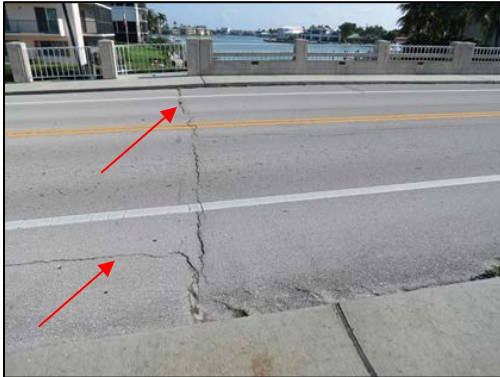
The FDOT Bridge Inspection Report lists the approach slabs as a Condition State of 2 (fair). The approach slabs are covered with an asphalt overlay. The begin (west) approach slab at End Bent 1, right shoulder, has a longitudinal crack up to 20 feet x 1/4 inch and a full width 1/2 inch transverse crack 2 feet west of the asphalt covered expansion joint. The end (east) approach slab has a longitudinal crack up to 18 feet x 1/4 in in the asphalt overlay in the right shoulder and a transverse crack 10 feet x 1/2 inch in the left shoulder and Lane 2 at the east approach roadway. There is a transverse crack up to 27ft. x 1/2in. in the asphalt overlay in the end approach slab that is 3 feet east of End Bent 4. The transverse cracks appear to line up

with construction joints shown in the record plans. We believe that water flowing down into these cracks has caused the undermining of the approach slabs and end bents.

Pavement cracks at approach slab for End Bent 1

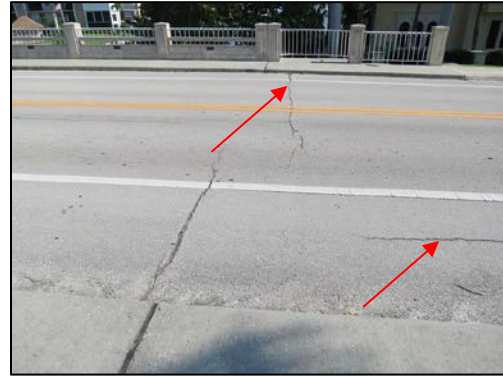
Pavement cracks at approach slab End Bent 4

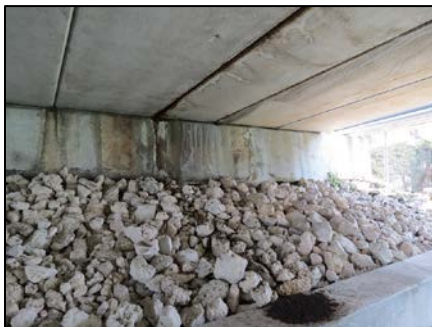
The FDOT Bridge Inspection Report lists the end bent caps as a Condition State of 1 (good). End Bent Cap 1 is intermittently undermined throughout up to 8 inches high x 40 inches under the cap with the piles exposed. End Bent Cap 4 is undermined at the center of the cap 36 feet long x 21 inches high x 42 inches under the cap with the piles exposed. See photos below. End Bent Cap 1 has a minor crack and minor spall at the location of the construction joint where the cap was widened in 2001 (no repairs required).

Undermining at End Bent 1

8. End Bent 1, temporarily remove some of the rip rap stones where settlement has occurred under the bent and tightly install sand bags in the voids under the end bent between the exposed piles. Reinstall the rip rap stones.

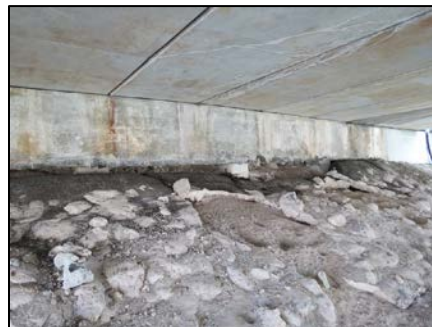
Undermining at End Bent 4

9. At End Bent 2, pulverize and disperse the existing failed rip rap materials as necessary between the end bent and the sea wall. Install sand bags in the voids under the end bent between the exposed piles to the front face of the bent. Install at least 5 layers of sand cement bags at the front face of the end bent with #4 rebar driven in the bags. Install a 6" minimum layer of #3 stone over the dispersed materials between the sea wall and newly installed sand cement bags at the front face of the end bent.

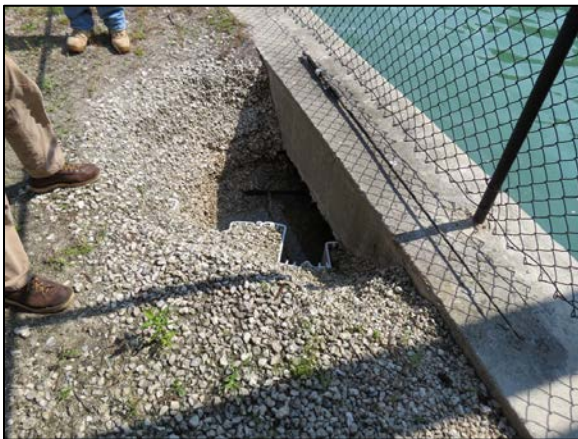
The west sea wall bulkhead has two up to 6 ft. x 4 ft. x 3ft. void/depression areas behind the bulkhead cap in the northwest and southwest corners. See photos below.

Sink hole on left side behind sea wall

7. Fill the voids behind the sea wall under Span 1 with low slump concrete up to level of the mean low water elevation and fill the remaining portion of the voids with #57 stone. The details for the means and methods for plugging of the holes on the canal side of the repair procedure will be delegated to the contractor.

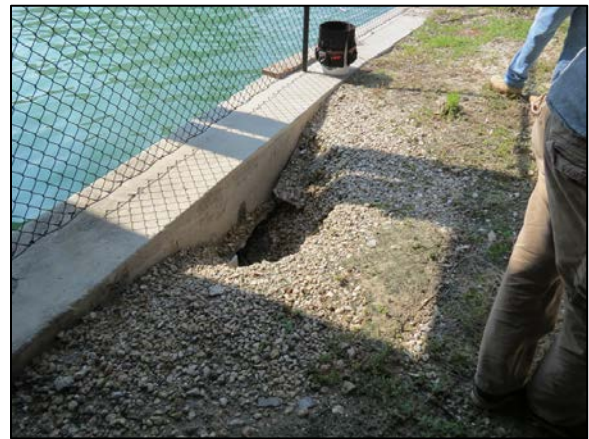
Sink hole on right side behind sea wall

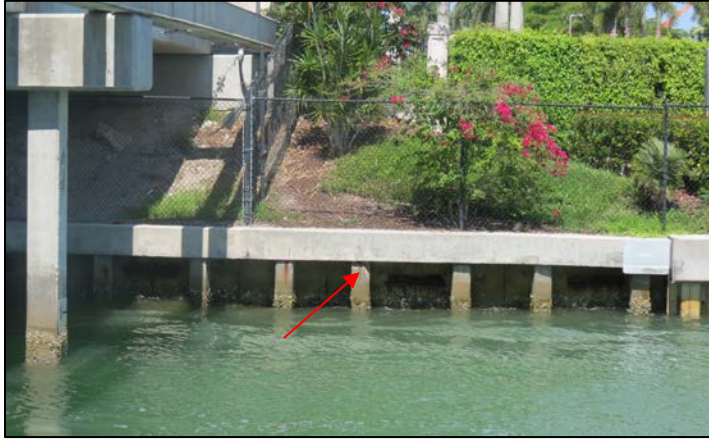
There are 7 exposed piles on the right (south) side of the east sea wall bulkhead that exhibit corrosion bleed out. The 4th pile from the joint with the private wall has a spall that is approximately 8 inches x 13 inches x 3 inches deep. There are 3 steel channels on the face of the wall (that are presumably connected to tie back anchors) are heavily rusted. See photos below.

Seven piles at East sea wall (arrow on pile with spall)

5. The bridge will be closed during the street level repairs with the traffic detoured to Park Shore Drive.
6. Perform concrete patching repairs on the 4th pile from the joint with the private wall on the southeast sea wall. Clean the other piles and apply a breathable coating on all of the seven (7) piles.

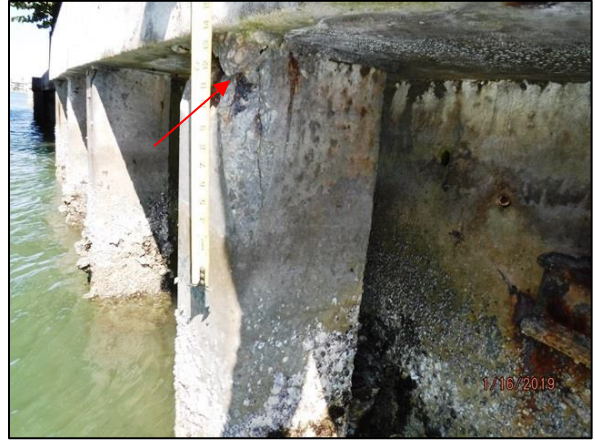
Close-up of pile spall and rusted channel

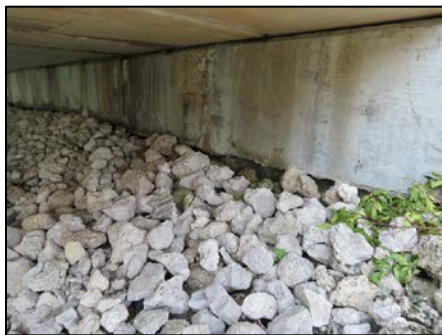
The slope protection at End Bent 1 consists of rock rubble. The slope protection at End Bent 4 consists of rip-rap with intermittent grout or asphalt topping. A portion of the slope protection at End Bent 1 exhibits minor settlement/displacement. The settlement and displacement throughout the slope protection at End Bent 4 has produced undermining up to 21 inches deep of the cap, exposing seven piles. See the photos below.

Slope protection at End Bent 1

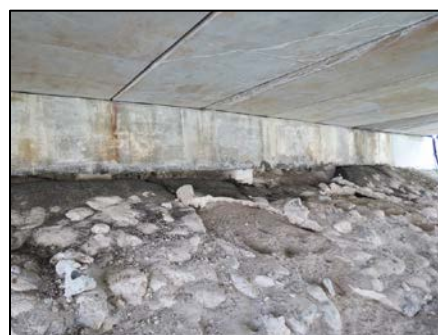
Slope protection at End Bent 4

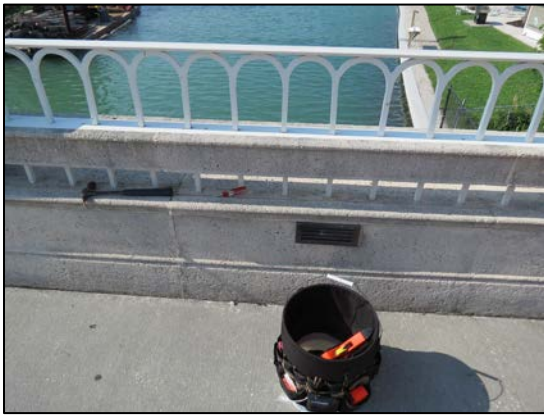
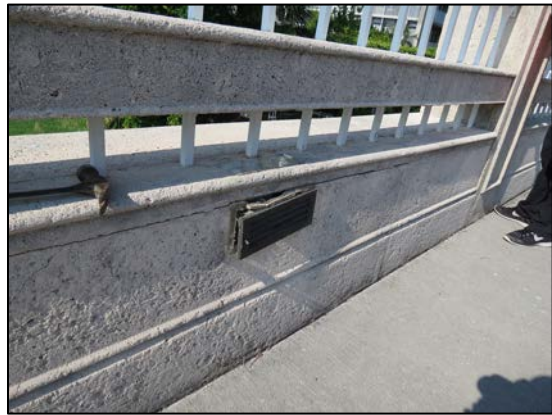
The aluminum bridge rails exhibit isolated areas of peeling paint. The concrete panels exhibit wide spread delamination from the substrate. The right railing in Span 2 has a 7'-9" length of concrete panel missing. Some of the flush mounted light fixtures are loose.

10. Re-install the section of missing cast stone on the right barrier that was salvaged by the City. Fabricate a new section of cast stone to replace the missing cast stone element. Require the contractor to provide 4 additional cast stone pieces that will be provided to the City for future use.

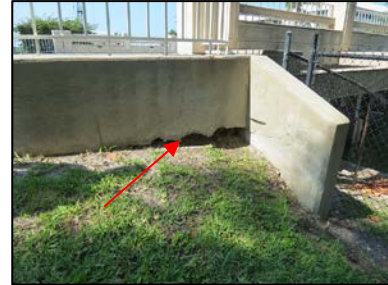
The left sidewalk overlook at End Bent 4 is undermined.

11. The undermined area under the sidewalk on the left side at End Bent 4 will be filled using sand bags.
12. The fencing will be replaced on the sea wall below Span 3 per the City's requirements.
