Subject: **Geotechnical Investigation Summary Report**
Baker Park Site
50 Riverside Circle
Naples, Collier County, Florida

GEOTECHNICAL INVESTIGATION SUMMARY REPORT

**Baker Park
50 Riverside Circle
Naples, Florida**

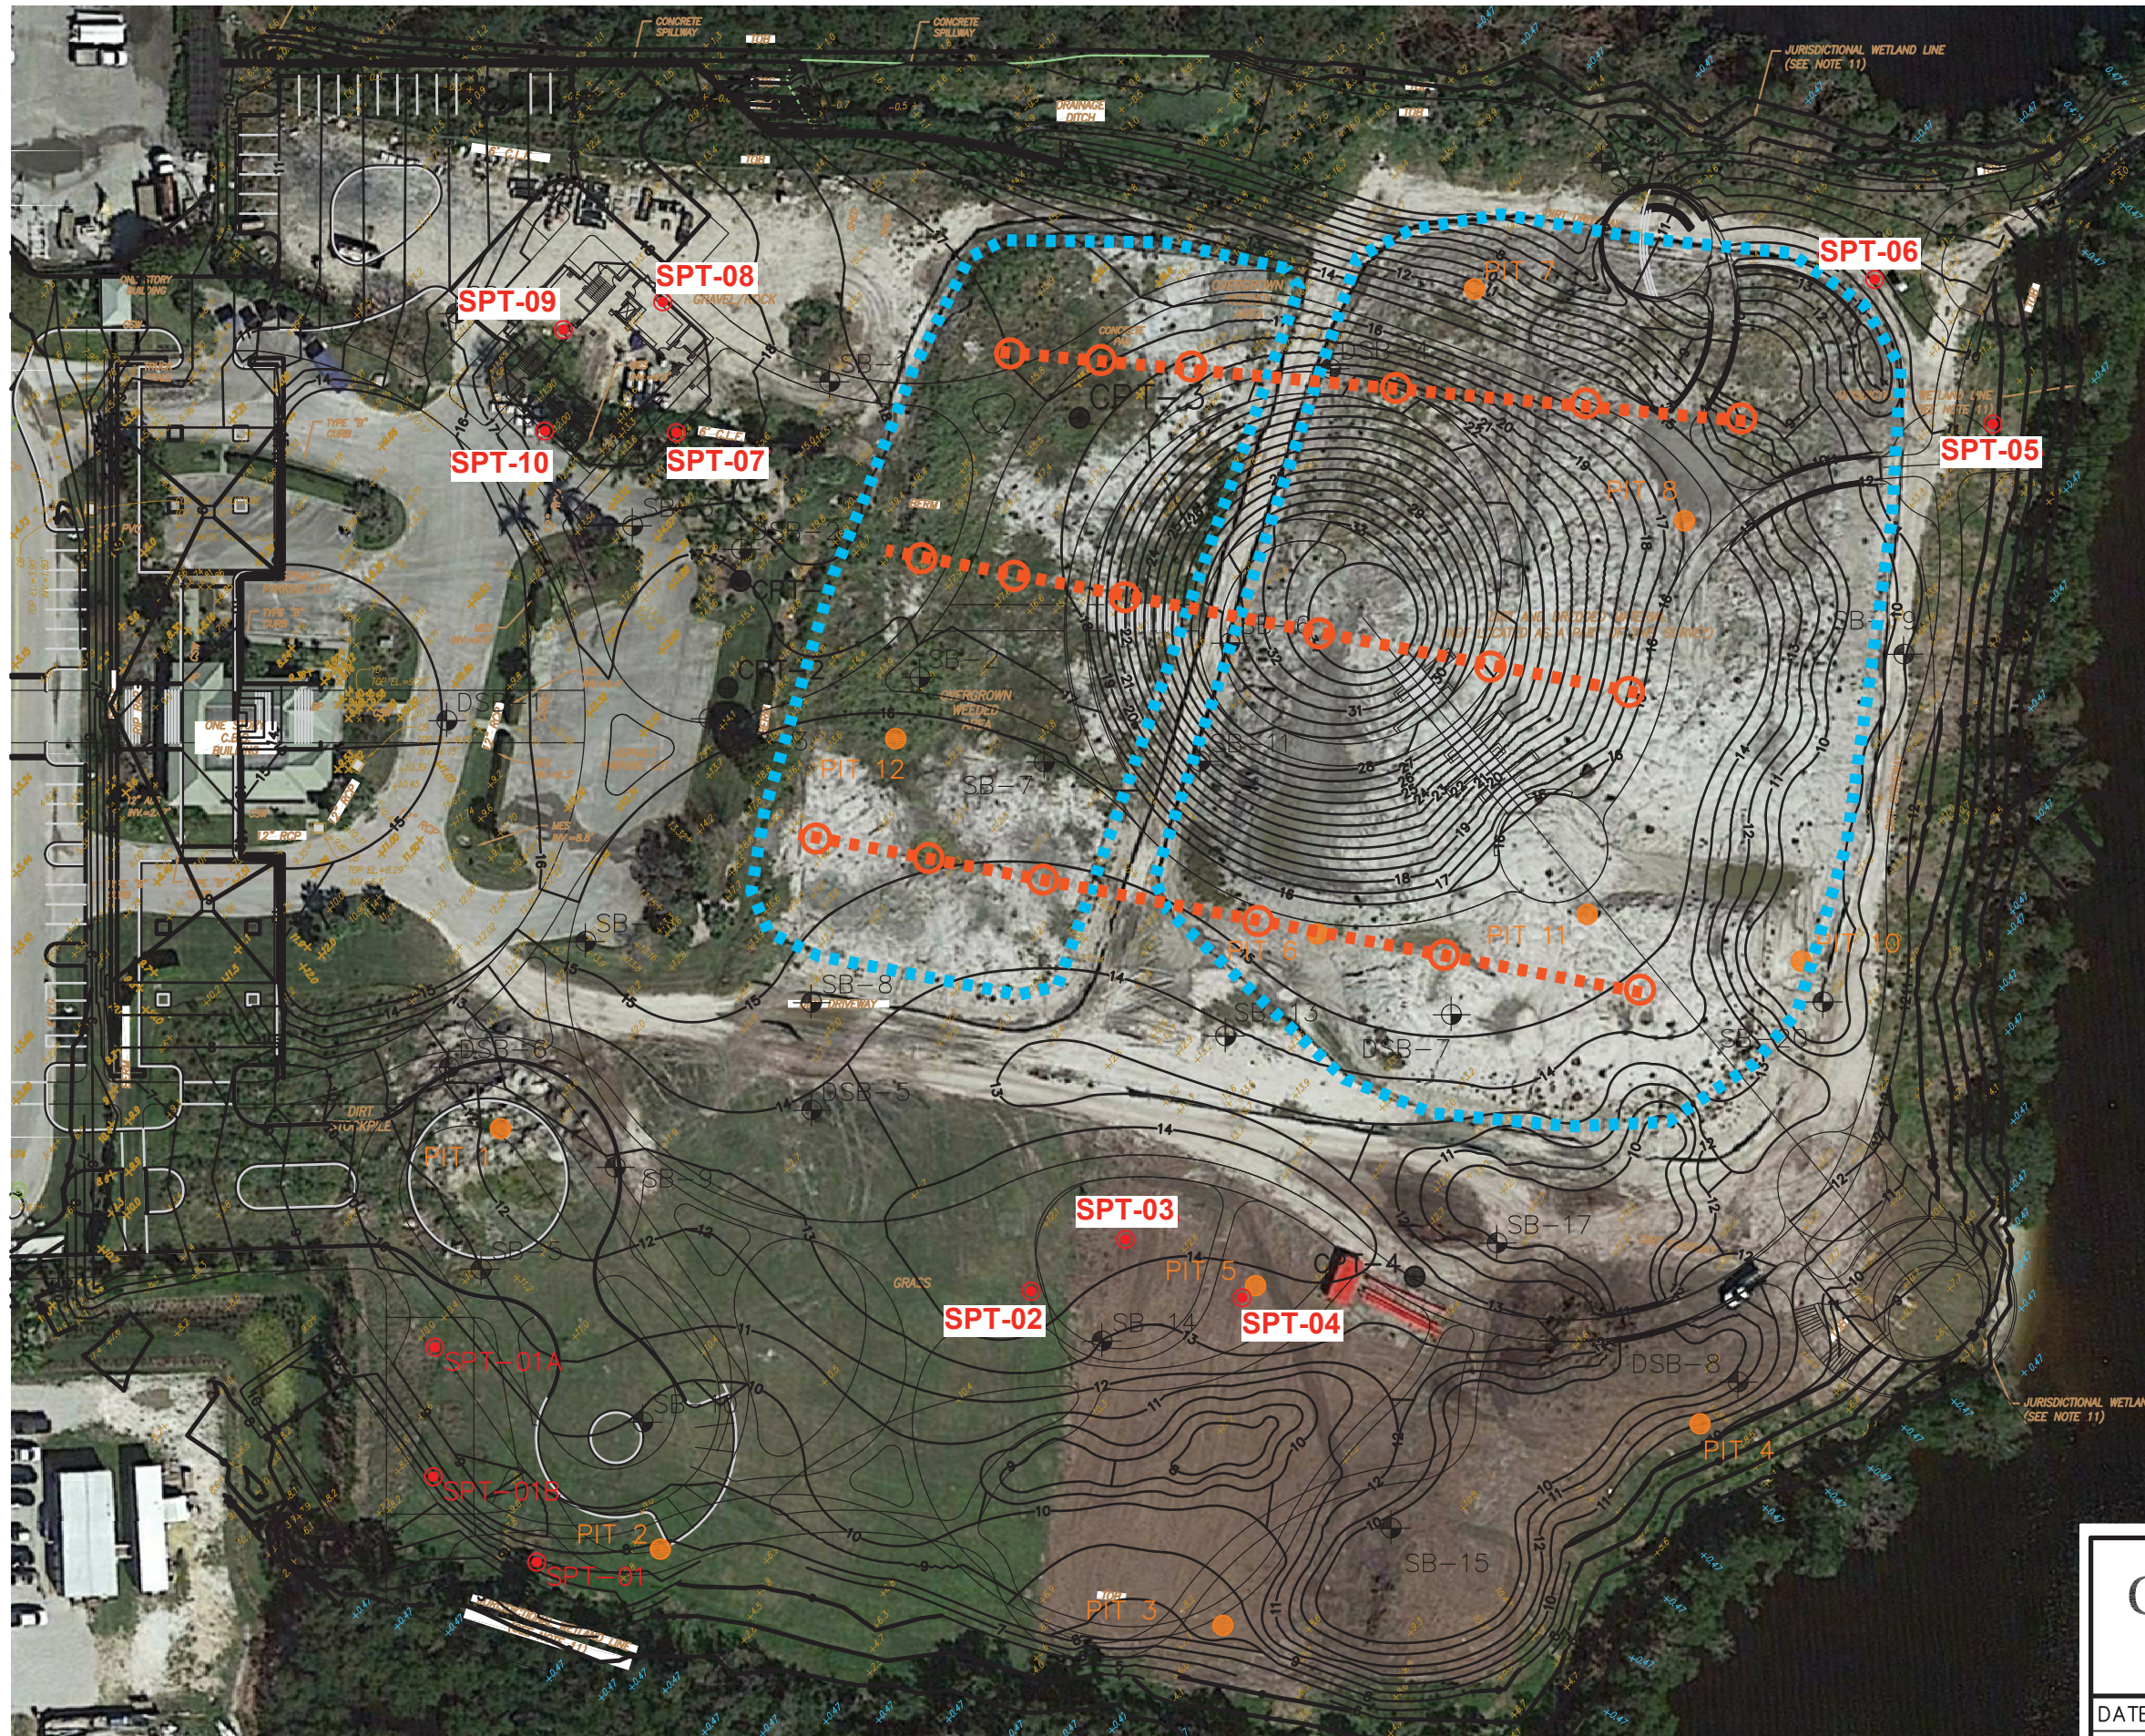
- HISTORICAL CDM SPT BORINGS
- HISTORICAL CDM CPT BORINGS
- HISTORICAL MACTEC TEST PITS
- GEOSYNTEC SPT BORINGS
- DREDGE SPOIL MOUND
- TRANSECT
- APP. HAND AUGER LOCATION

- 18 hand auger borings were advanced along three (3) transect lines to approximately 2-ft bgs at the dredge spoil mounds as noted on **Figure 2**. Six (6) auger borings were composited into one (1) soil sample for a total of three (3) composite samples (HA-01 to HA-03).

As noted previously, a kayak launch building was proposed in the southwest portion of the Site (as shown on Conceptual Site Plan H2) and Geosyntec had proposed one (1) boring, SPT-01, as illustrated on **Figure 2**. Due to restricted access, Geosyntec was unable to complete a soil boring in this general area. Also, **Figure 2** presents two (2) borings (SPT-01A and SPT-01B) that are proposed as part of a supplementary geotechnical investigation and were not included as part of this mobilization.

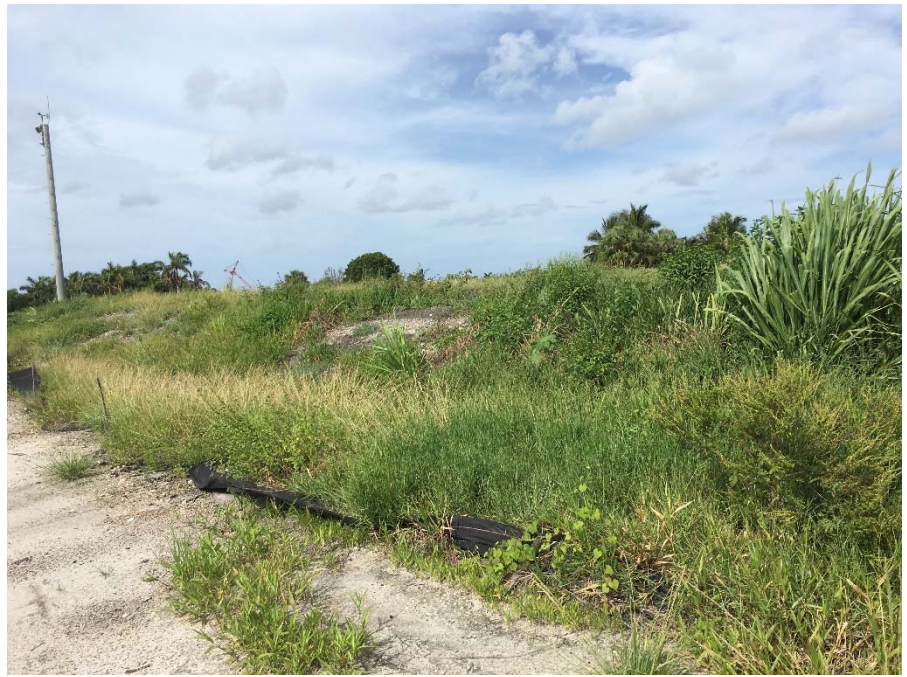
Comments: View of west dredge spoil mound. The mound is heavily vegetated with grass and small shrubs. The mound is encircled by a silt fence.

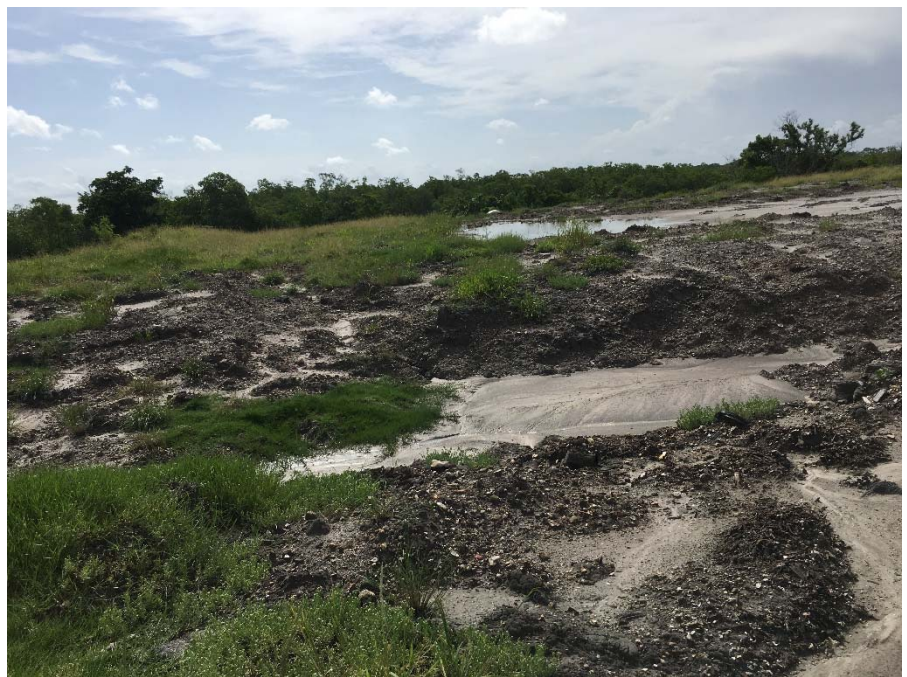
Photograph 2

Comments: View along top of east dredge spoil mound. Rill erosion due to a lack of vegetation is visible along the surface of the mound.

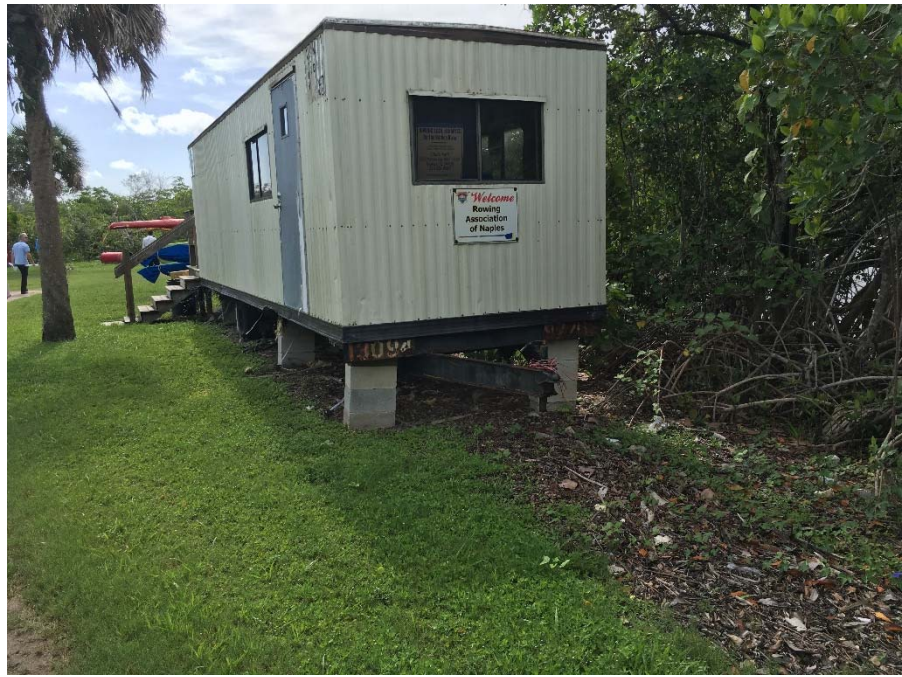
Comments: View of office trailer for the Rowing Association of Naples, located on the northeast peninsula.

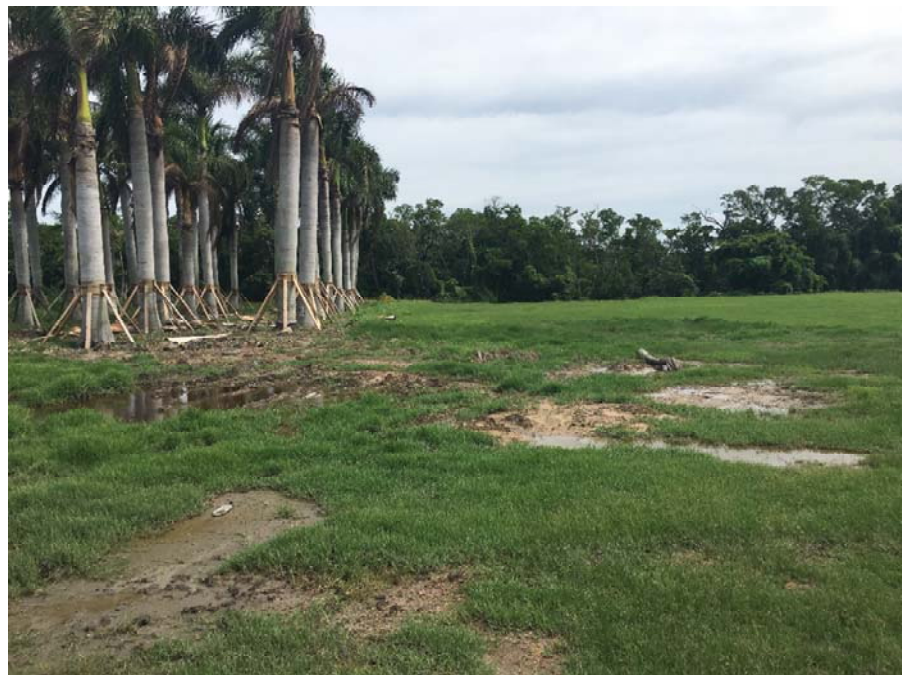
Photograph 4

Comments: View of temporary palm staging area. At the foreground, low lying saturated areas are visible due to recent rain events.

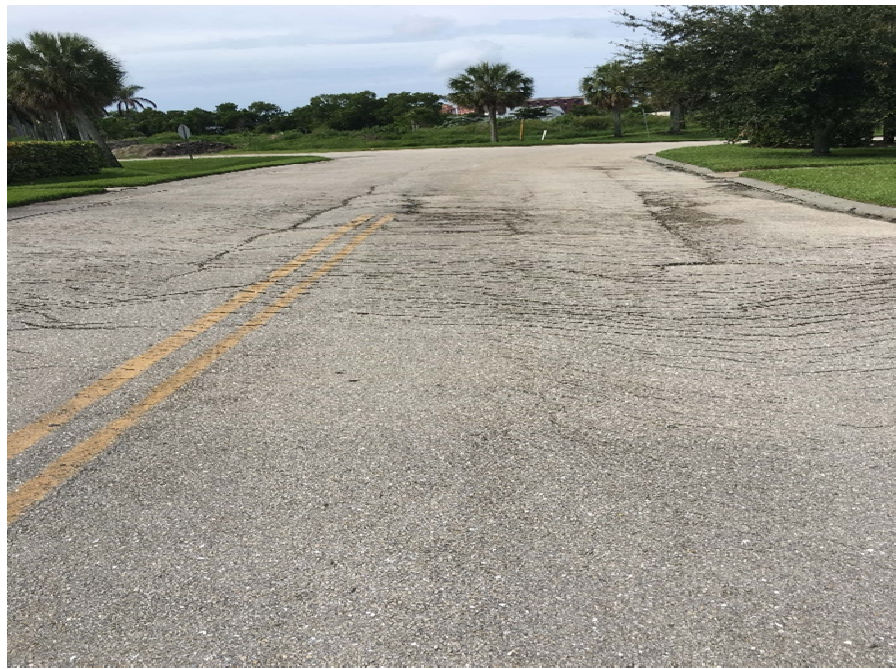
Comments: View of pavement in the parking area of former Solid Waste Operations building. The pavement appears distressed.

As a preliminary consideration for pavement design, it is recommend that a flexible pavement system, in accordance with the Florida Department of Transportation (FDOT), “*Flexible Pavement Design Manual*”, March 2015, be installed at the Site due to subsurface Site conditions. Specifically, pavement design considerations should include accounting for the compressible characteristics of the horticultural debris layer and utilization of appropriate pavement stabilization or reinforcement methods (e.g. mechanically stabilized aggregate layer) to minimize long term settlement and subsequent pavement maintenance.

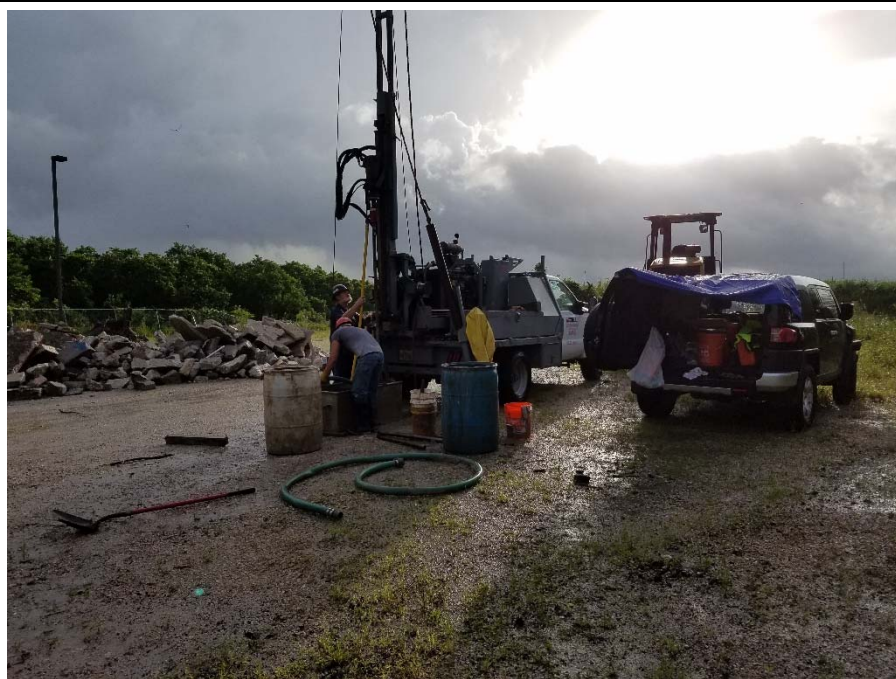
Photograph 6

Comments: View of SPT drilling activities at SPT-08. In the background is a stockpile of concrete.

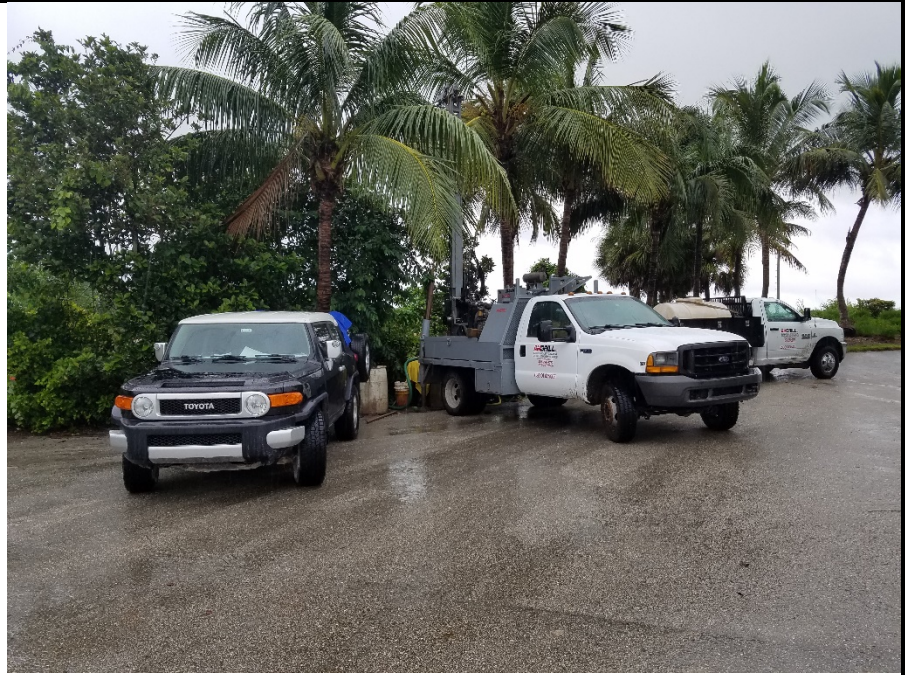
Comments: View of SPT drilling activities at SPT-10. The boring was located near the existing parking area of the former Solid Waste Operations building.

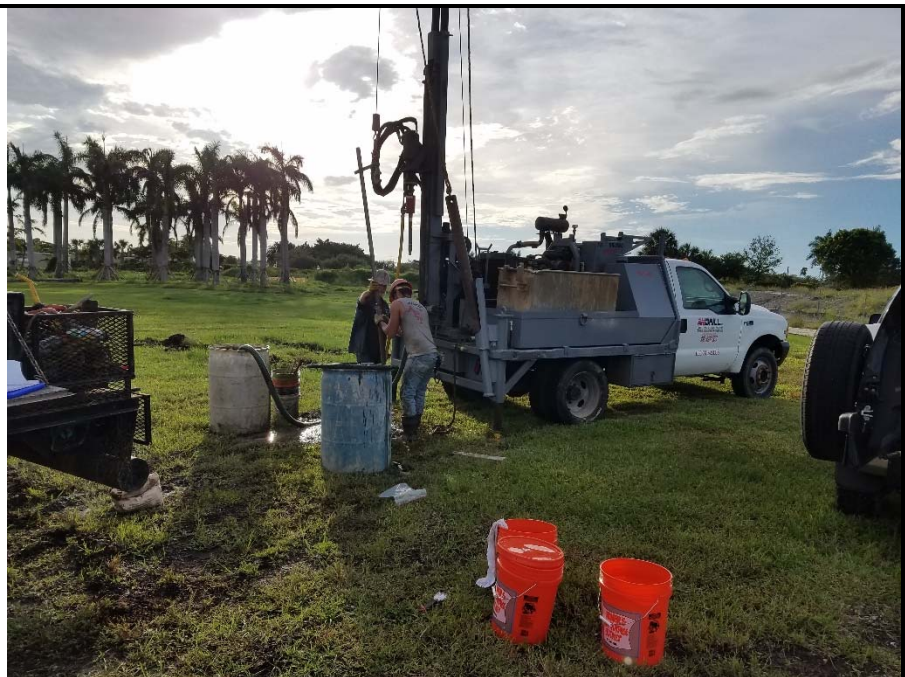
Photograph 8

Comments: View of SPT drilling activities at SPT-03. The temporary palm staging area is visible in the background.
