APPENDIX C

GEOTECHNICAL REPORTS

East Naples Bay
Rock Boring and Geotechnical Investigation
To: Dr. Michael Bauer
From: Jeffrey R. Tabar

**RE: Geotechnical Services Summary
East Naples Bay Dredging Project
Collier County, Florida
Tierra Project No. 6511-09-042**

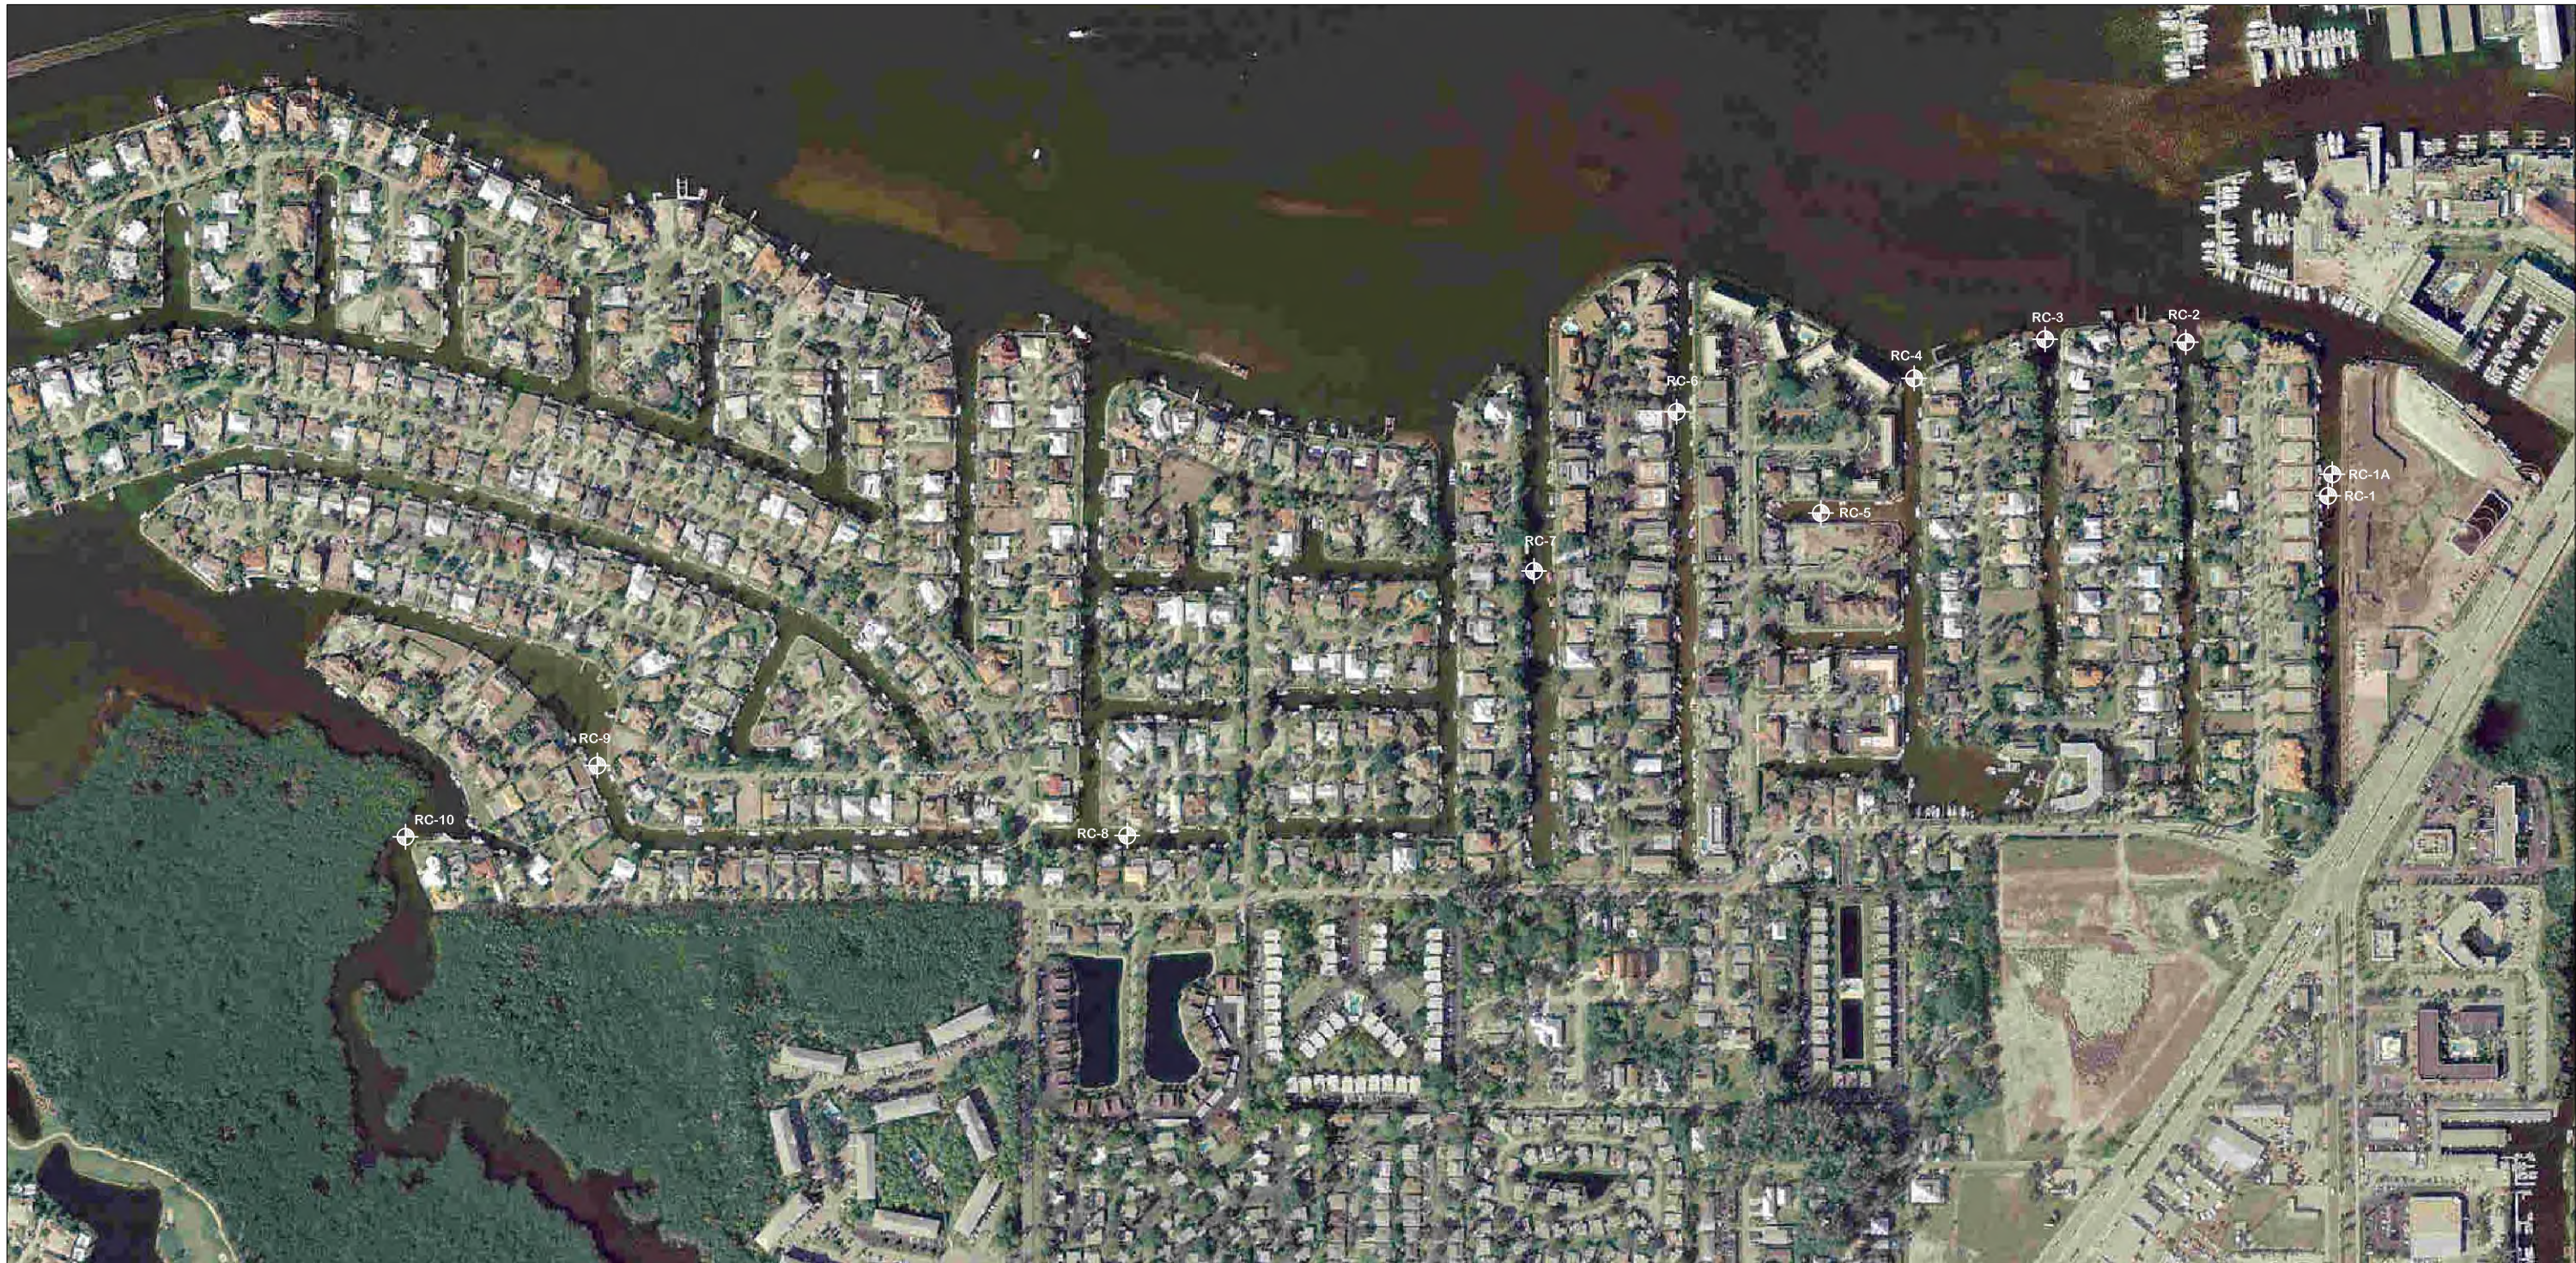
BORING LOCATION PLAN

APPROXIMATE LOCATION OF SPT BORING

The location of the selected core boring sites was based on previous jet probe results, water depths, and proximity to areas to be dredged. A figure showing the core locations can be found in Appendix 1. The table below summarizes some of the field data collected during the borings.

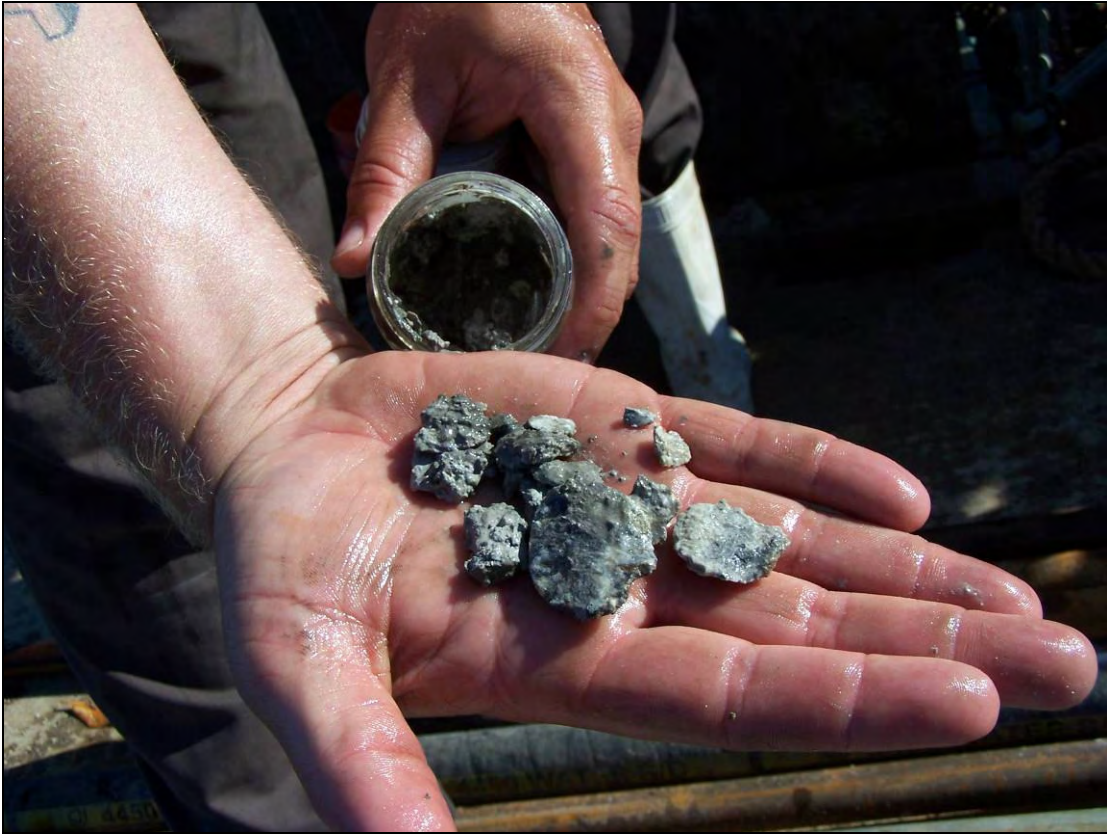
RC-1

Split spoon recovery from rock boring depth of 0ft to 2ft

RC-1: The bottom elevation at this boring location is -5.3ft NGVD. From -5.3ft to -7.3ft, the material is clayey sand with shell. This SPT for this material required eight blows for one foot of penetration. From -7.3ft to -9.3ft, the material is silty sand with shell and limestone fragments, which required twelve blows for one foot of penetration. From -9.3ft to -11.3ft, the material is cemented sand with limestone fragments, which required four blows for one foot of penetration. From -11.3ft to -13.3ft, the material is silty sand with shell and limestone fragments, which required four blows for one foot of penetration. The final portion of the boring from -13.3ft to -15.3ft is extremely weathered limestone rock with a soft consistency, which only required one blow for one foot of penetration. Note: No rock was encountered above -5.5ft NGVD. Therefore, it was decided to move the boring location approximately 200ft east and retry. The additional boring location was named “RC-1A.”

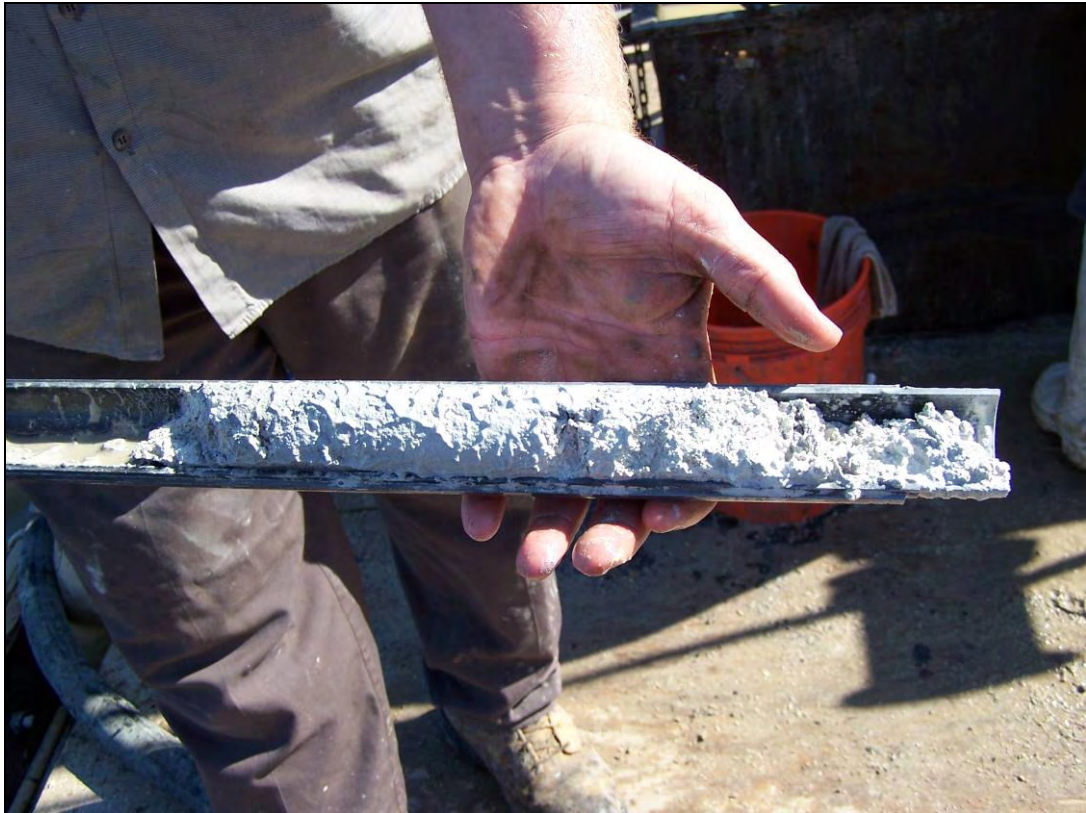
Split spoon recovery from rock boring depth of 2ft to 4ft

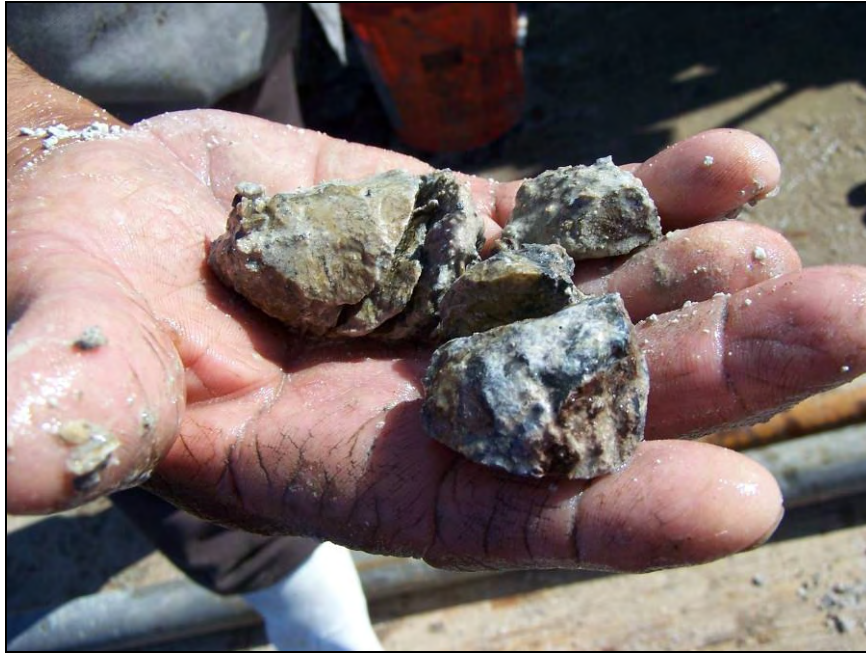
RC-1

Split spoon recovery from rock boring depth of 4ft to 6ft

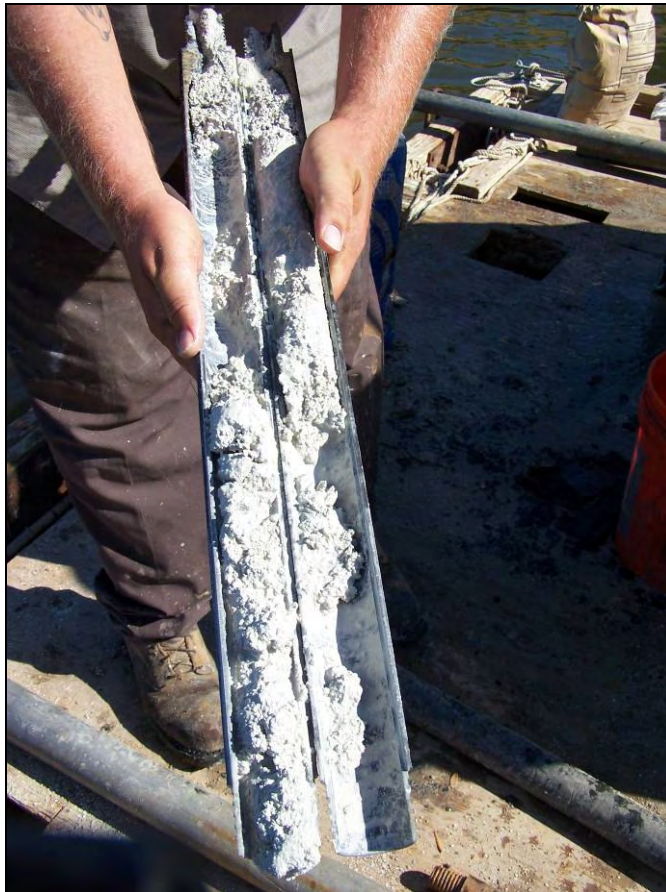
Split spoon recovery from rock boring depth of 6ft to 8ft

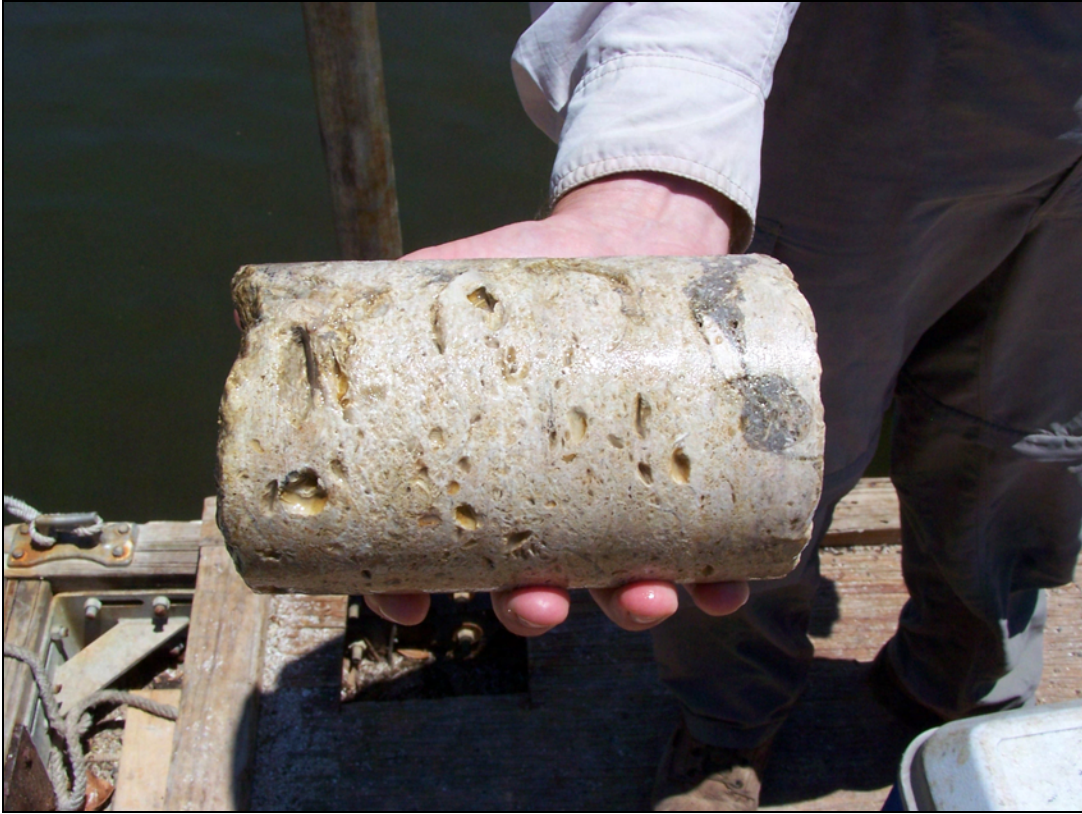
RC-1A

Rock core recovery from rock boring depth of 0ft to 1ft

RC-1A: The bottom elevation at this boring location is -3.6ft NGVD. From -3.6ft to -4.6 ft, the material is cemented limestone rock, which required fifty blows for only one inch of penetration. At this location, a limestone core run was able to be conducted through approximately one to two feet of rock. A thirteen inch sample of limestone rock was able to be recovered (See Appendix 2 for picture). The rock sample had an unconfined compression strength of 4,440psi, a rock

quality designation of 83%, and a recovery percentage of 100%. Note: This boring and core was conducted in the same canal as RC-1, but was moved approximately 200ft east from RC-1 to allow for a suitable limestone core run.

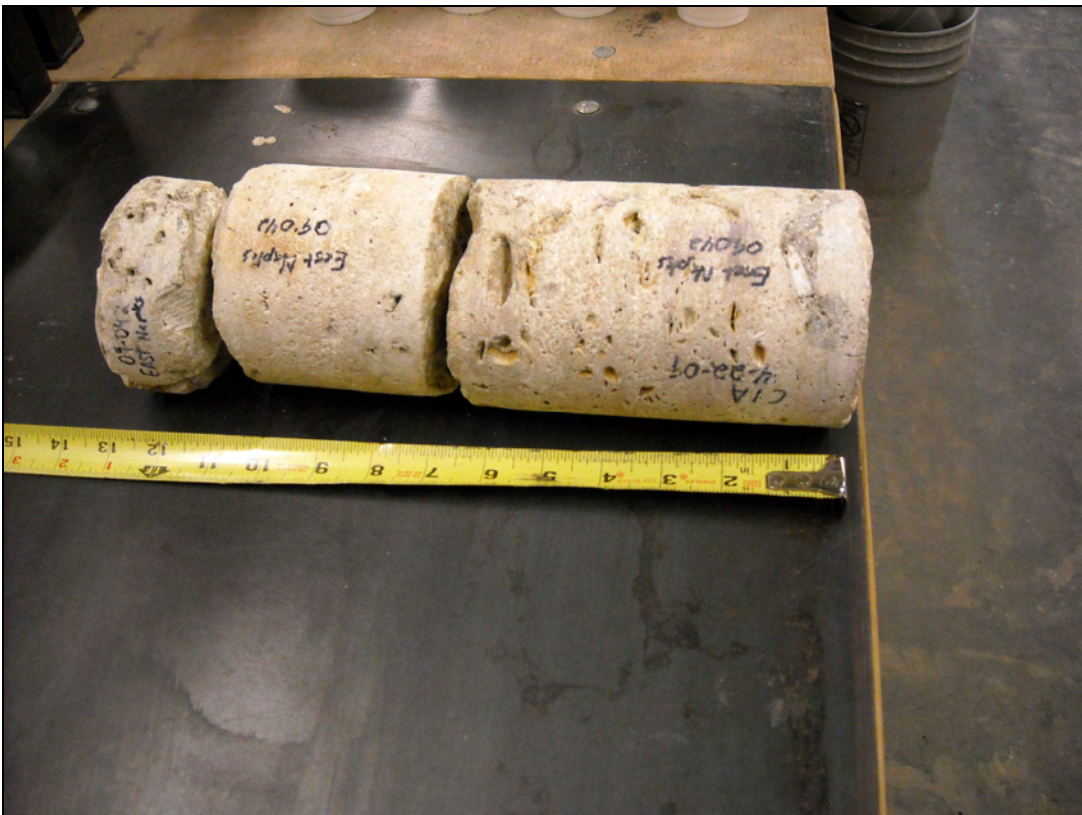
Rock core recovery dried in lab

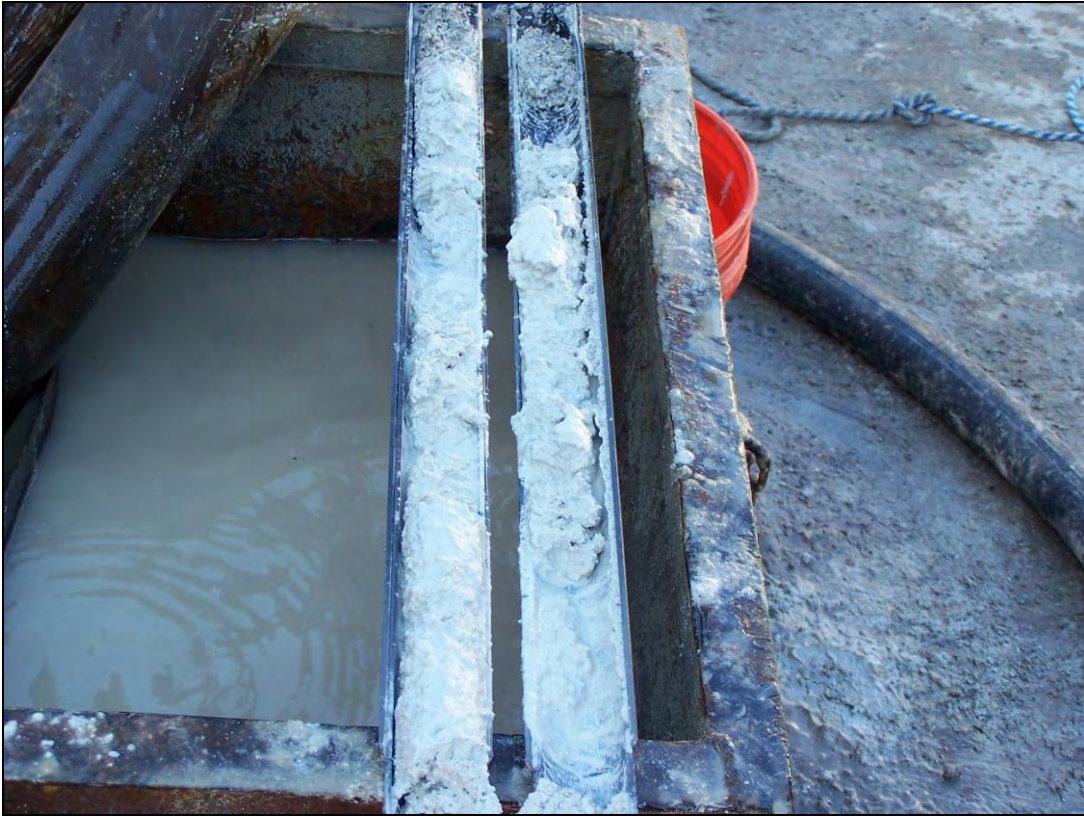
RC-5

Split spoon recovery from rock boring depth of 4ft to 6ft

RC-5: The bottom elevation at this boring location is -3.7ft NGVD. From -3.7ft to -4.7ft, the material is silty sand with organic material, which was penetrated by the weight of the hammer. From -4.7ft to -5.7ft, the material is slightly weathered, very to extremely hard limestone rock,

requiring fifty blows for only four inches of penetration. From -5.7ft to -6.7ft, the material is weathered limestone, having only a moderately hard consistency, which required twenty-five blows for one foot of penetration. The final portion of the boring from -6.7ft to -12.7ft, the material is cemented limestone and shell with a soft consistency, only requiring two blows for one foot of penetration.

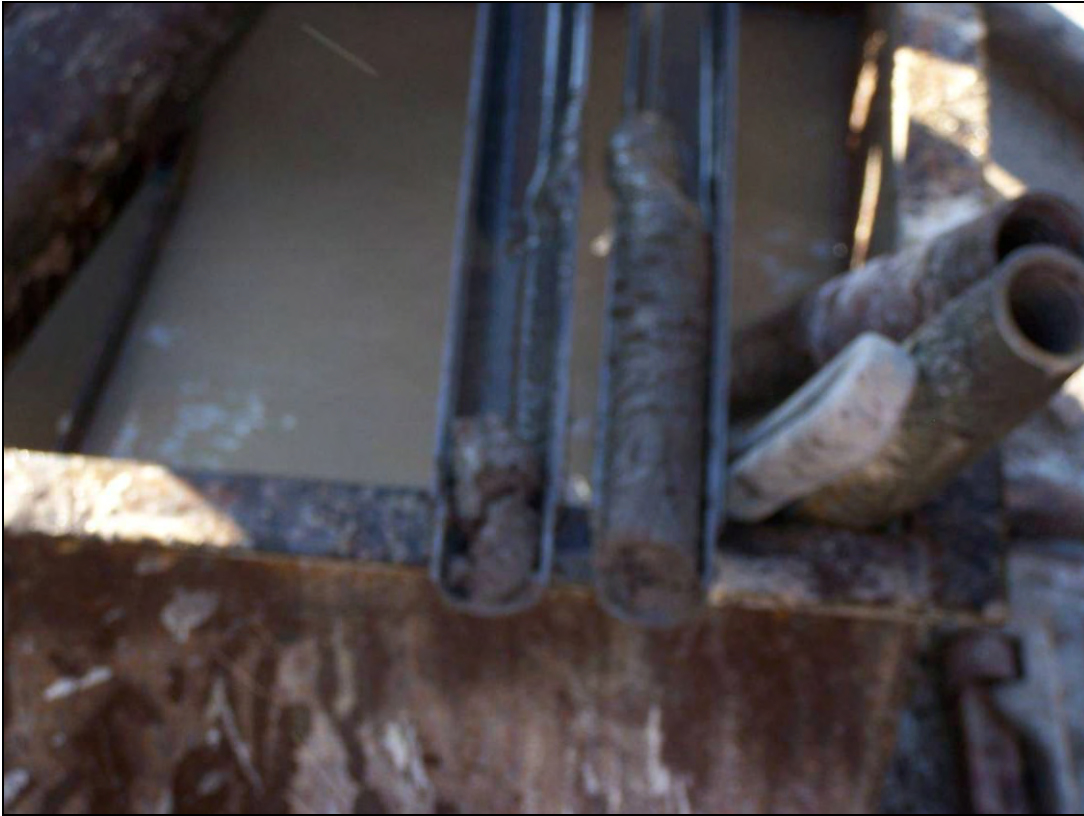
RC-6

Split spoon recovery from rock boring depth of 0ft to 2ft

RC-6: The bottom elevation at this boring location is -4.6ft NGVD. From -4.6ft to -5.1ft, the material is silty sand with organic material. From -5.1ft to -6.1ft, the material is slightly weathered, very to extremely hard limestone rock, which required fifty blows for only one inch of penetration. The final portion of the core from -6.1ft to -14.6 is cemented shell and limestone rock, with a firm consistency, requiring five blows for one foot of penetration.

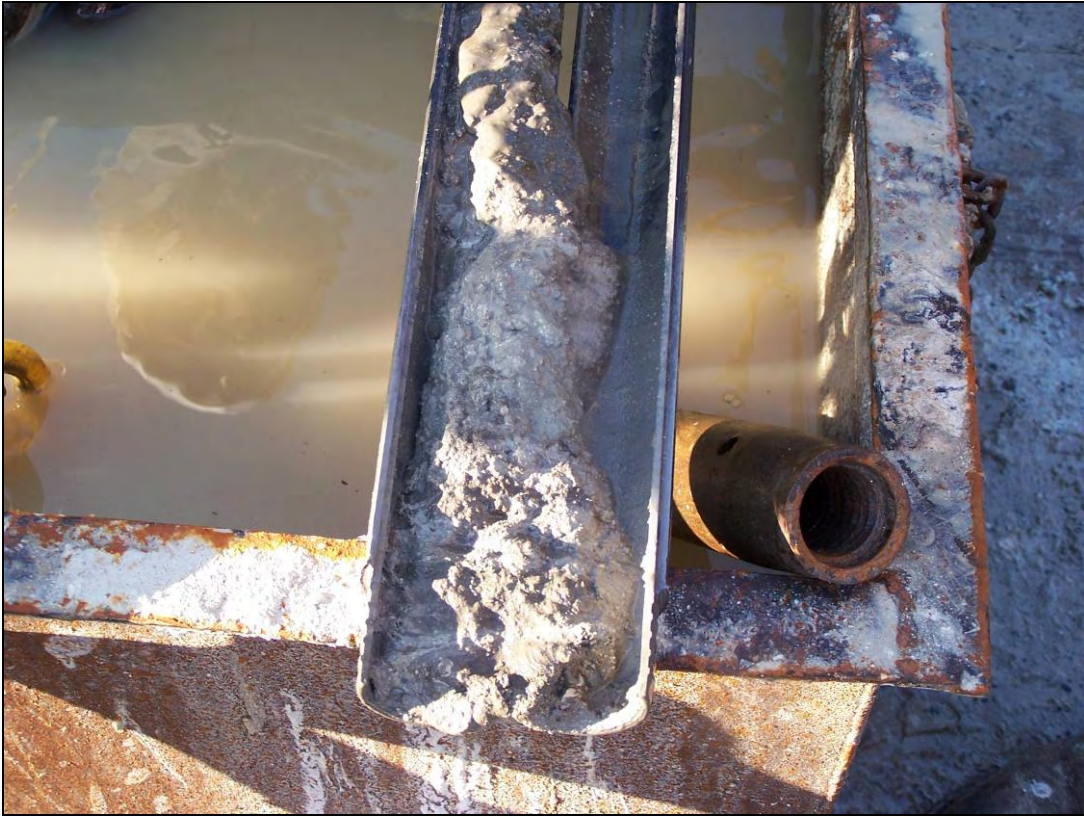
RC-7

Split spoon recovery from rock boring depth of 0ft to 2ft

RC-7: The bottom elevation at this boring location is -4.2ft NGVD. From -4.2ft to -5.2ft, the material is slightly weathered, very to extremely hard limestone rock, which required fifty blows for only two inches of penetration. From -5.2ft to -6.2ft, the material is silty sand with limestone fragments. From -6.2ft to -8.2ft, the material is cemented shell and limestone, requiring six blows for one foot of penetration. The final portion of the boring from -8.2ft to -14.2ft is cemented shell and limestone material with a firm consistency, requiring five blows for one foot of penetration.

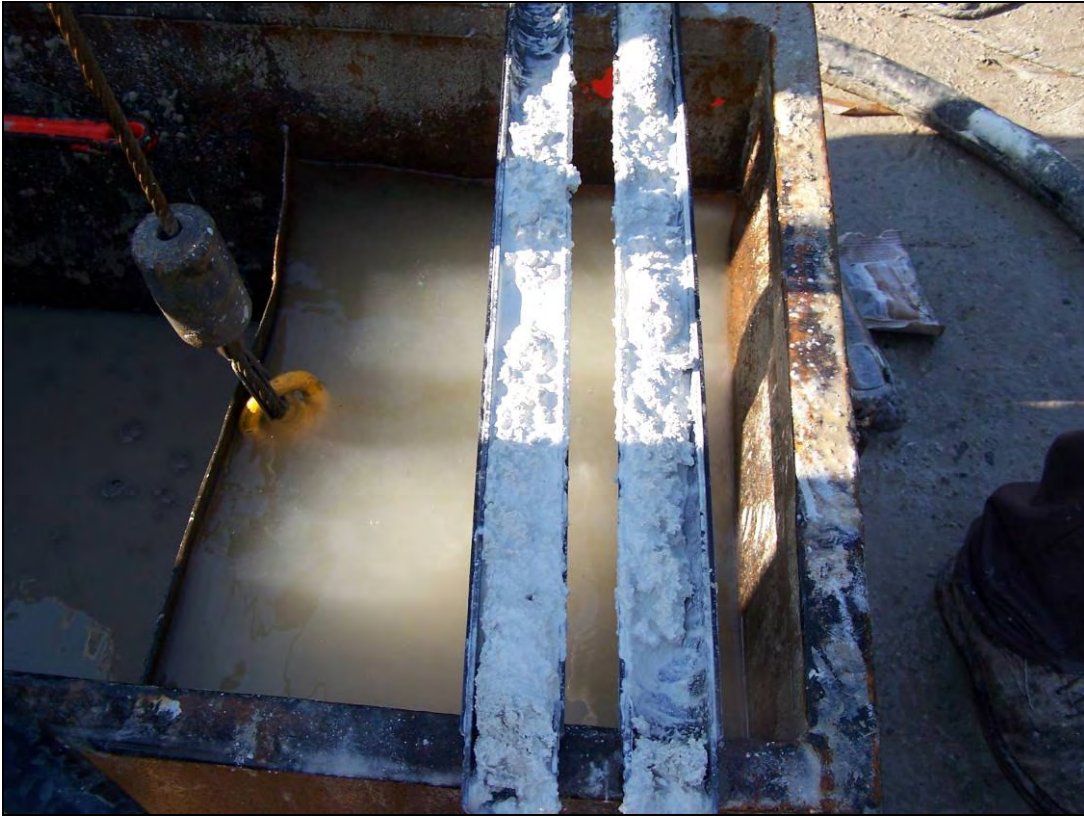
RC-7

Split spoon recovery from rock boring depth of 4ft to 6ft

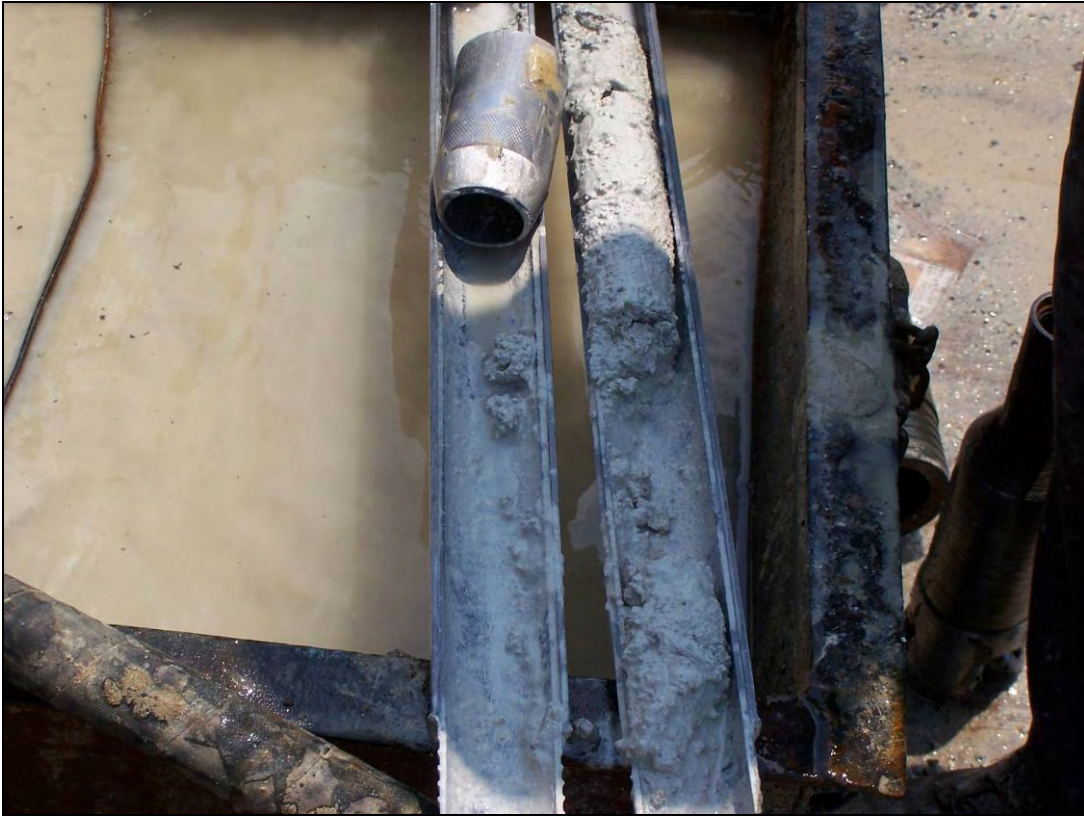
RC-9

Split spoon recovery from rock boring depth of 4ft to 6ft

RC-9: The bottom elevation at this boring location is -4.5ft NGVD. From -4.5ft to -5.5ft, the material is silty sand with shell and limestone fragments. From -5.5ft to -6.5ft, the material is slightly weathered, very to extremely hard limestone rock, requiring fifty blows for five inches of penetration. From -6.5ft to -8.5ft, the material is silty sand with shell and limestone fragments. From -8.5 to -10.0ft, the material is cemented shell and limestone with a very stiff consistency, requiring twenty-four blows for one foot of penetration. The final portion of the core from -10.0ft to -14.5ft is cemented shell and limestone material with a firm consistency, requiring six blows for one foot of penetration.

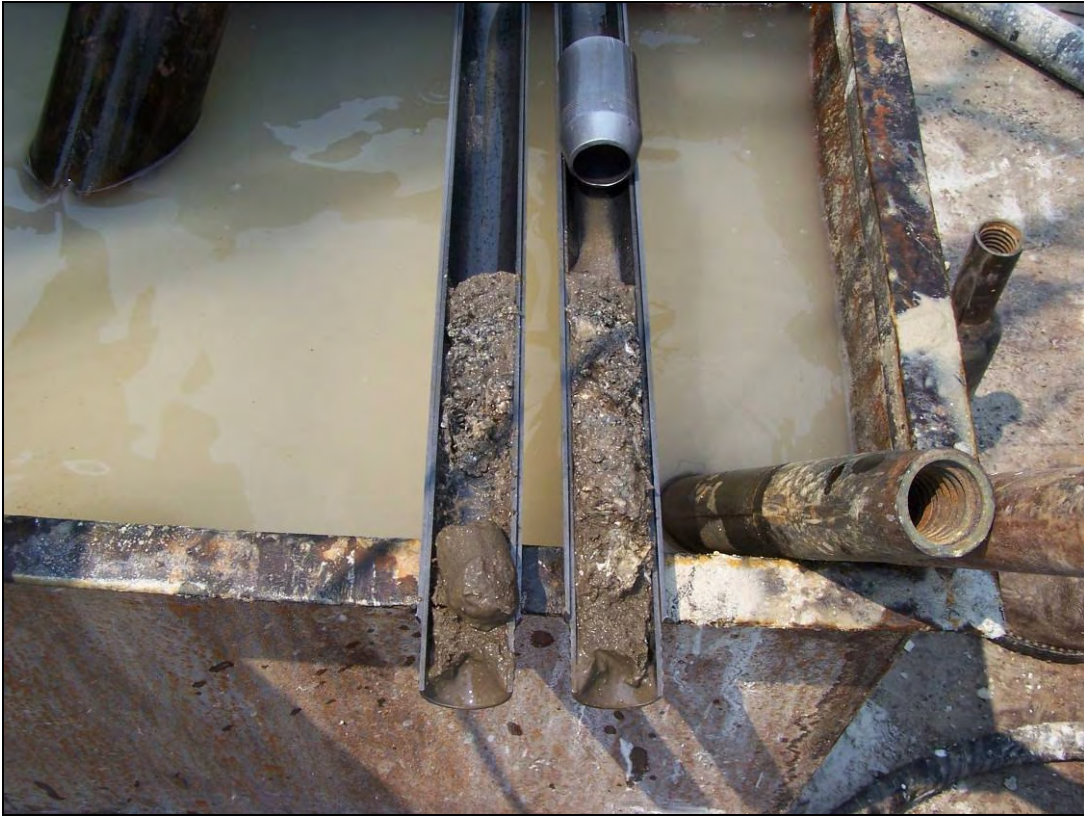
RC-10

Split spoon recovery from rock boring depth of 0ft to 2ft

RC-10: The bottom elevation at this boring location is -2.6ft NGVD. From -2.6 ft to -6.6ft, the material is cemented shell and limestone fragments, requiring four blows for one foot of

penetration. From -6.6ft to -9.6ft, the material is weathered limestone rock, with a very hard consistency, requiring fifty blows for five inches of penetration. At this location, a limestone core run was able to be conducted through approximately seven inches of rock. A seven inch sample of limestone rock was able to be recovered (See Appendix 2 for picture). The rock sample had an unconfined compression strength of 8,070psi, a rock quality designation of 33%, and a recovery percentage of 50%.

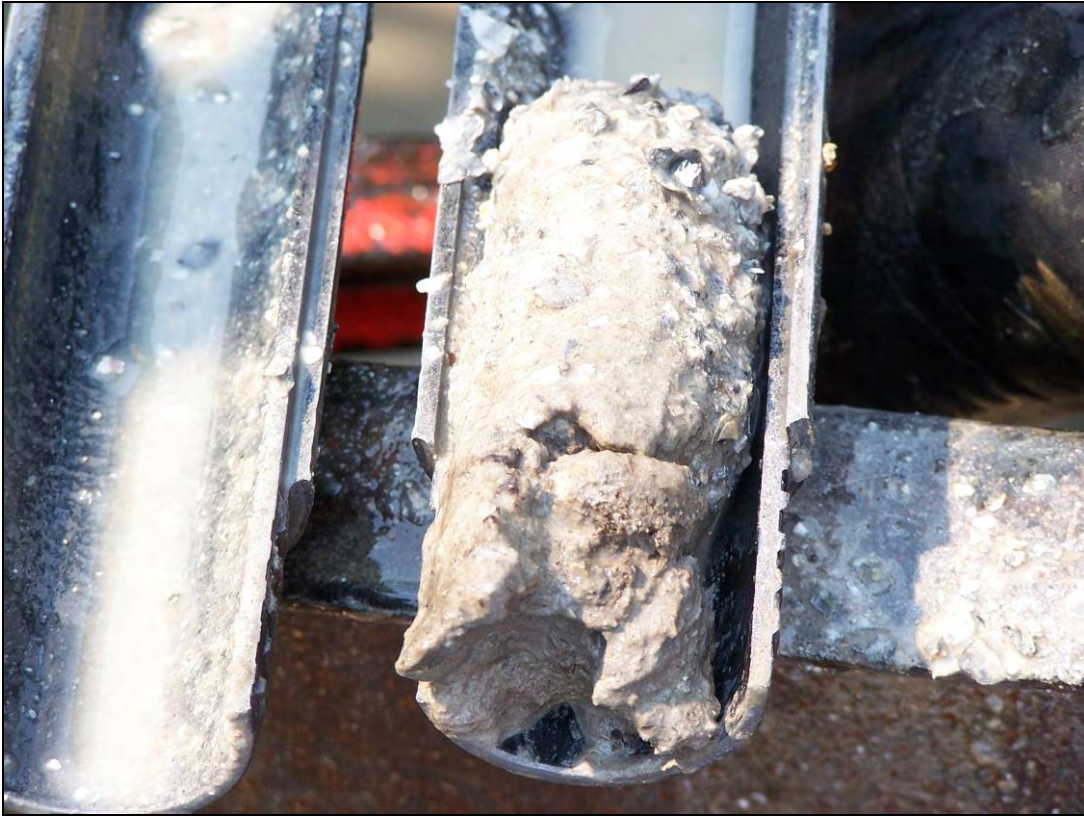
RC-10

Split spoon recovery from rock boring depth of 4ft to 6ft

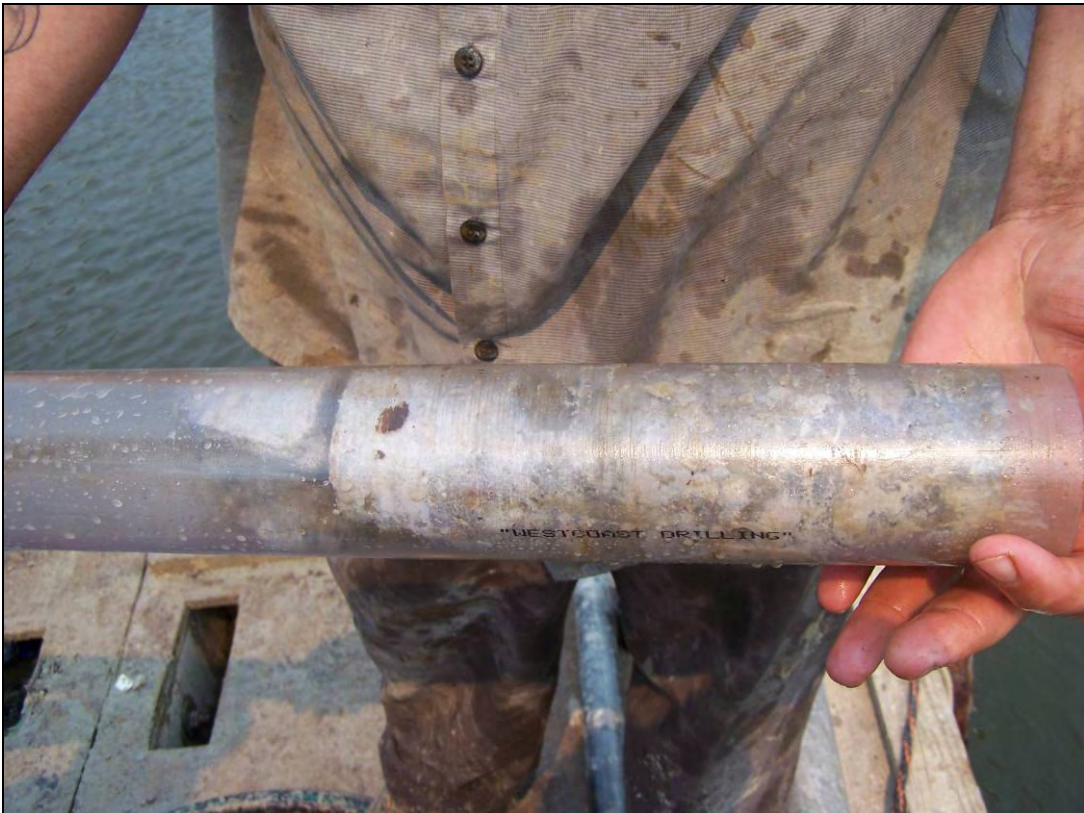
Rock core recovery from rock boring depth of 6ft to 8ft

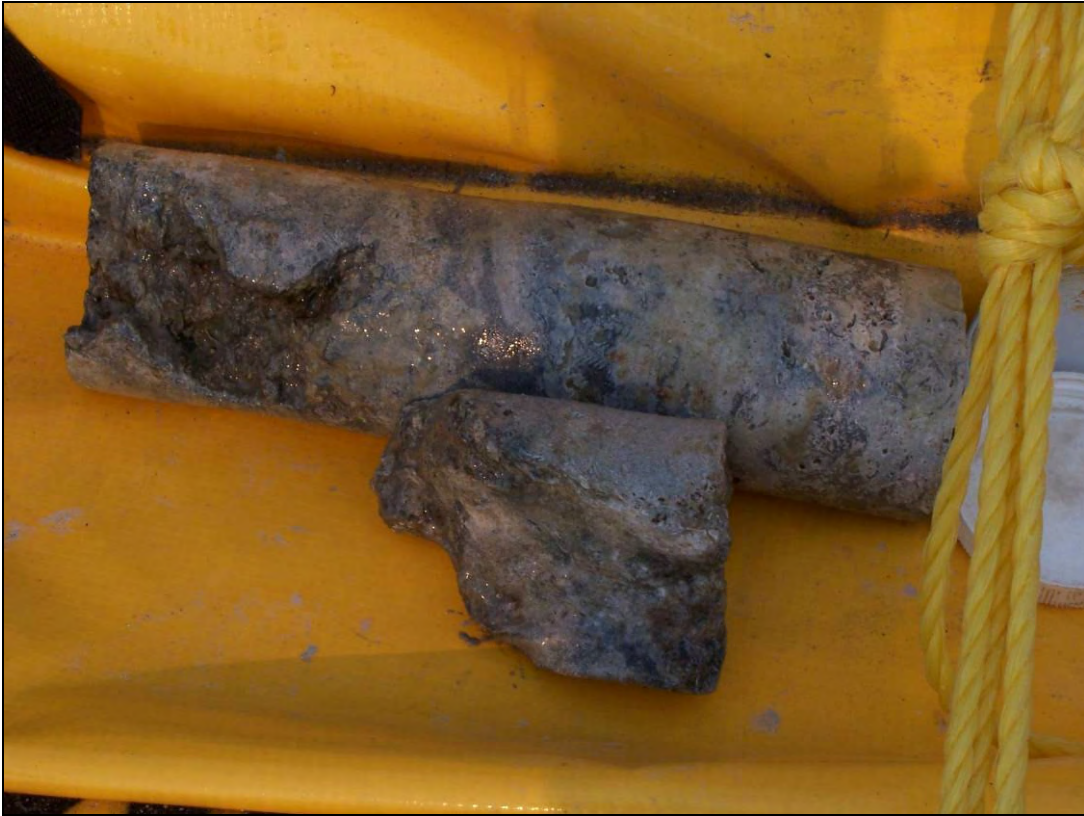
RC-10

Rock core recovery from rock boring depth of 6ft to 8ft

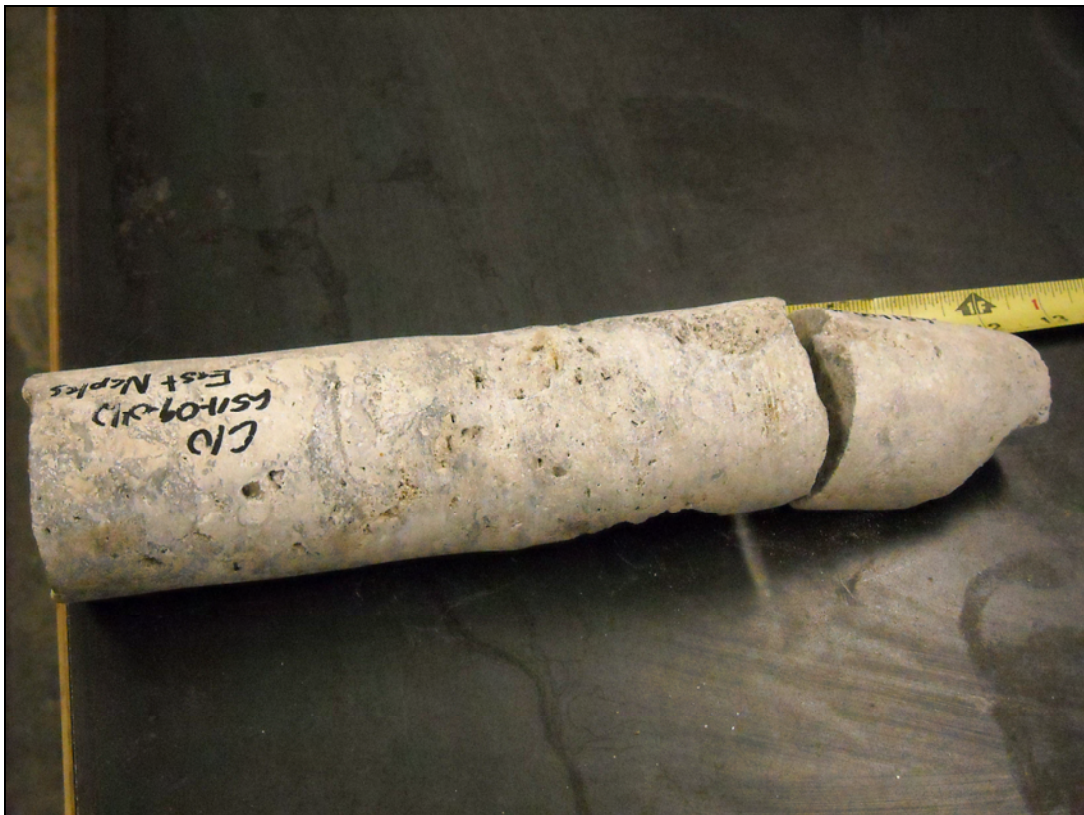
Rock core recovery dried in lab
